Commercial Property Report

Production Facility

18501 [REDACTED] Drive
Parker, CO 80134

Introduction

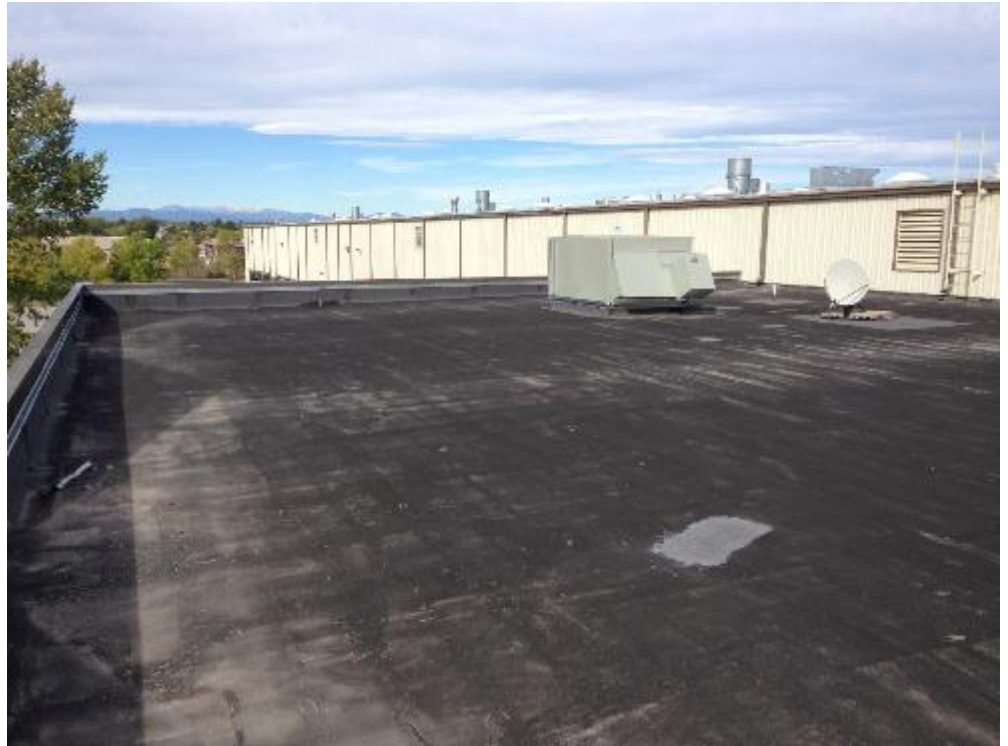
5 IMG_9178

This is an overview of the landing area above the employee entrance.

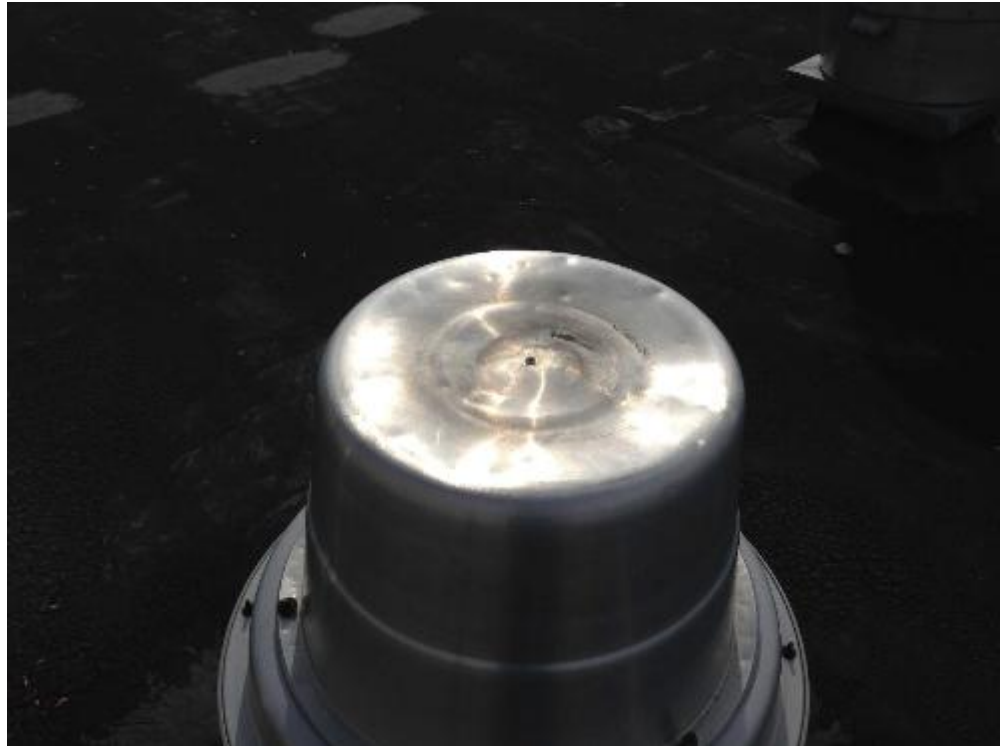
7 IMG_9182

Hail damage to an exhaust fan on the landing above the employee entrance.

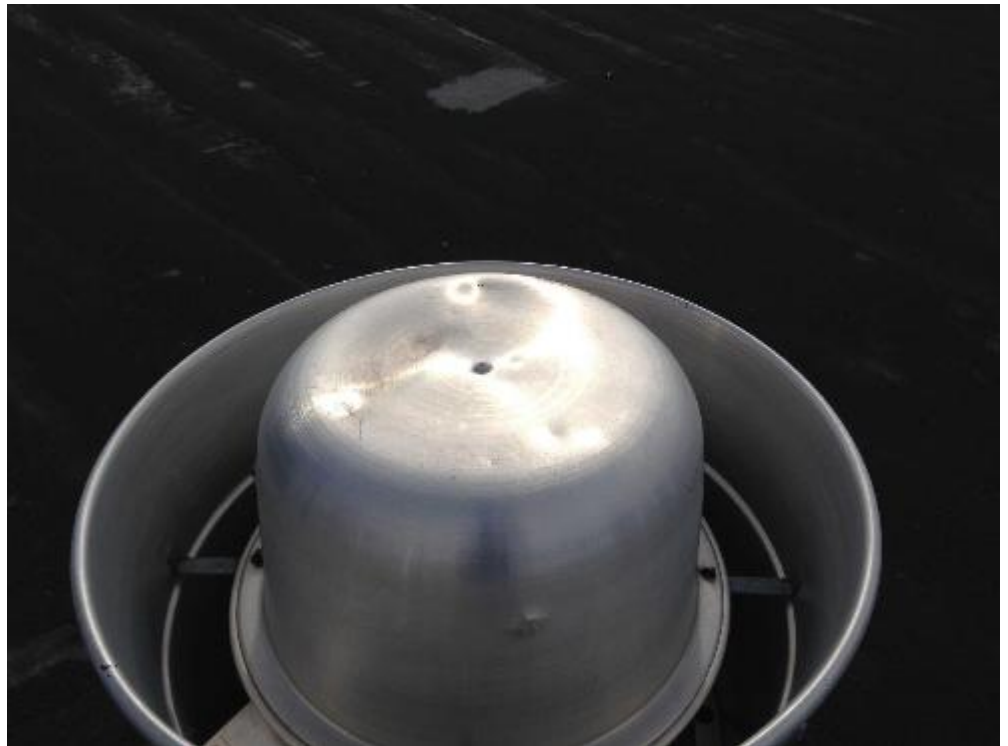
8 IMG_9185

The gravity roof ventilator on this elevation also shows signs of hail damage.

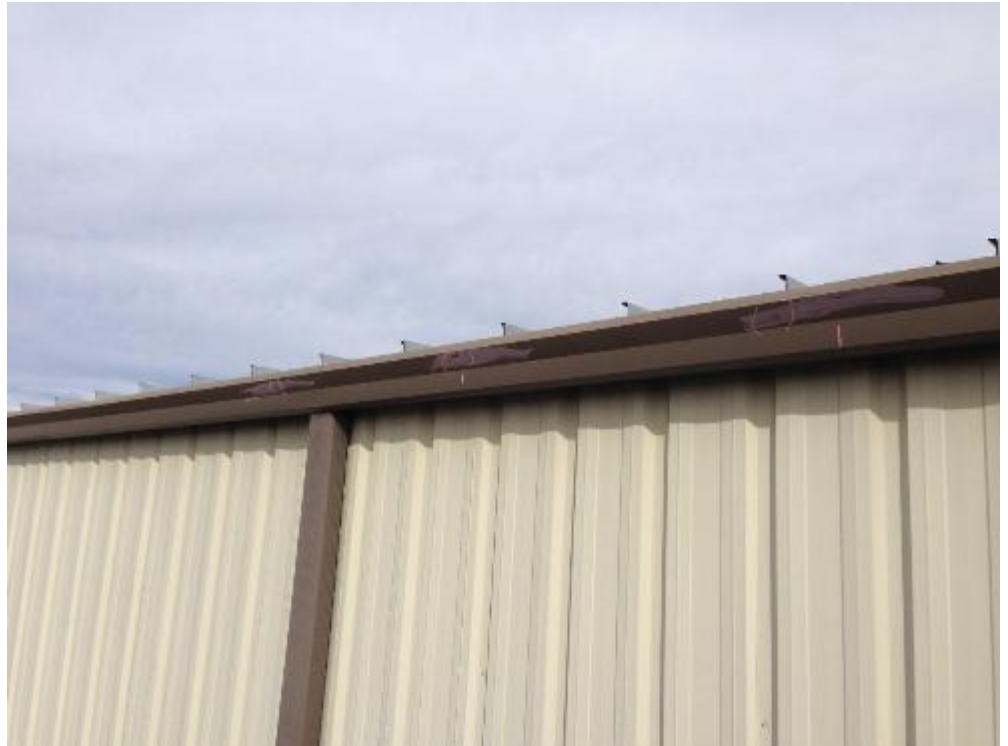
11 IMG_9191

Dents in the gutters caused by hail.

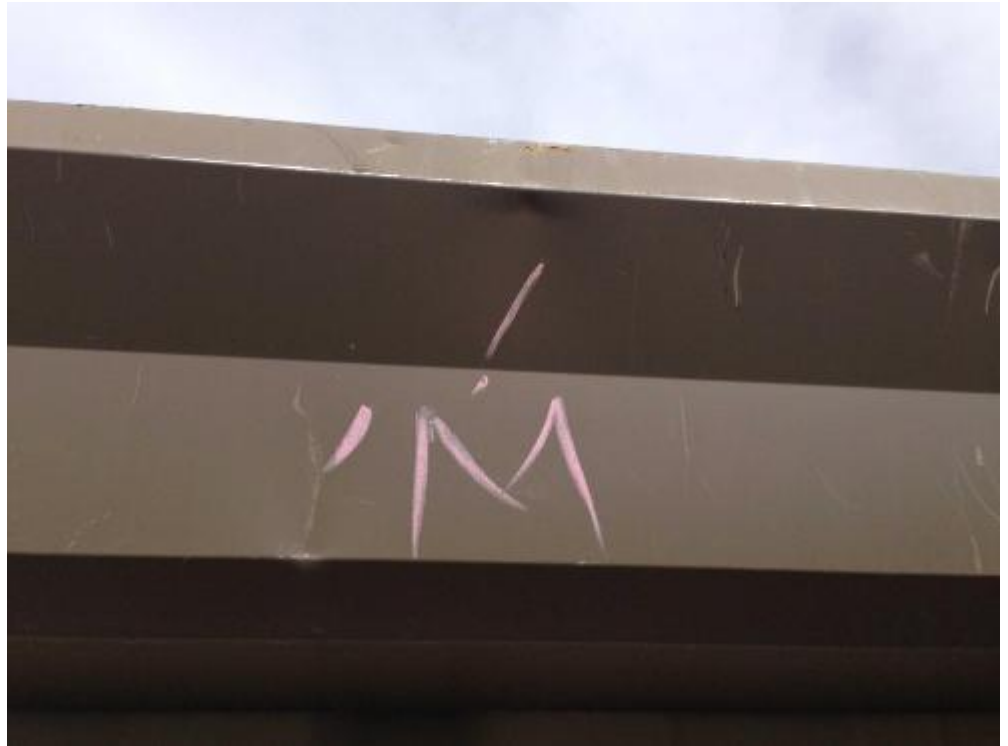
- 13 Mechanical Damage to
Date Taken: 10/8/2013
Taken By: Derek O'Driscoll

Note the sharp creases and scratch,
this is a sign the damage was
mechanically caused.

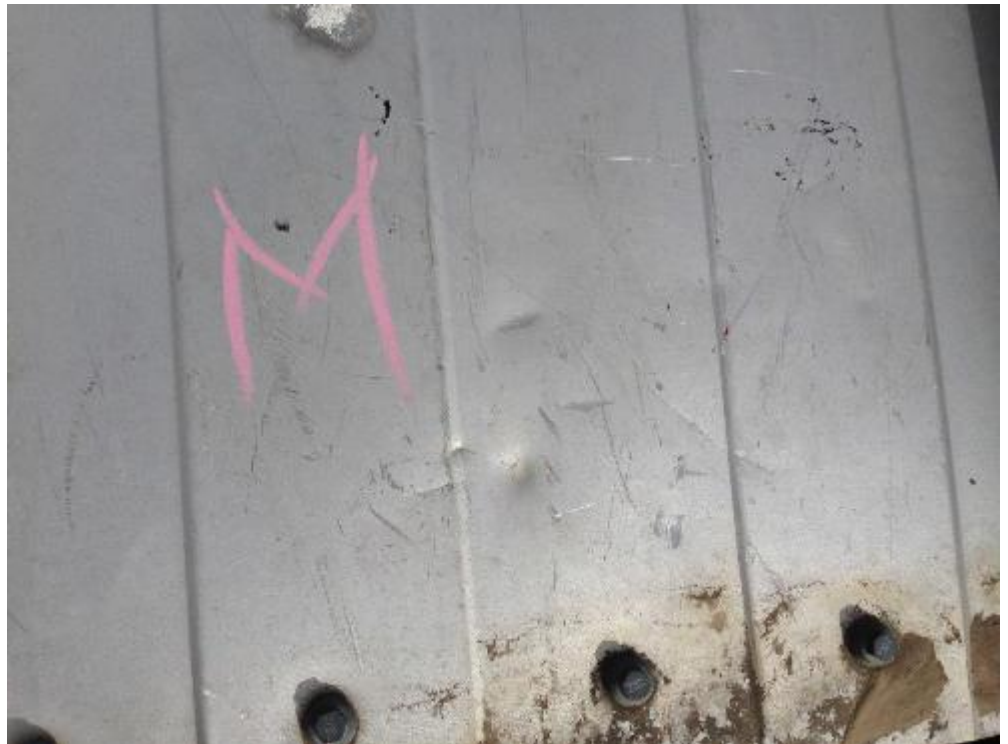
- 14 Mechanical Damage So
Date Taken: 10/8/2013
Taken By: Derek O'Driscoll

This area of damage is directly off the
ladder to the roof system, a likely
place for technicians and contractors
to place items, which is likely the
caused of this damage.

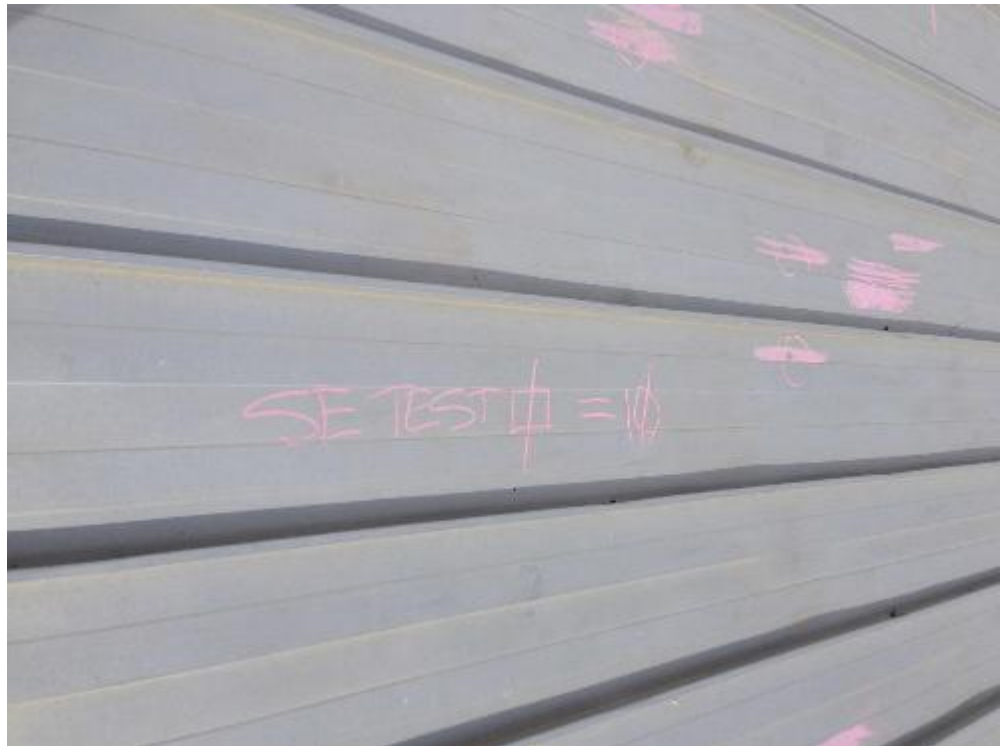
- 16 SE Test Square Ident
Date Taken: 10/8/2013
Taken By: Derek O'Driscoll

Identifier and results for the South East test square.

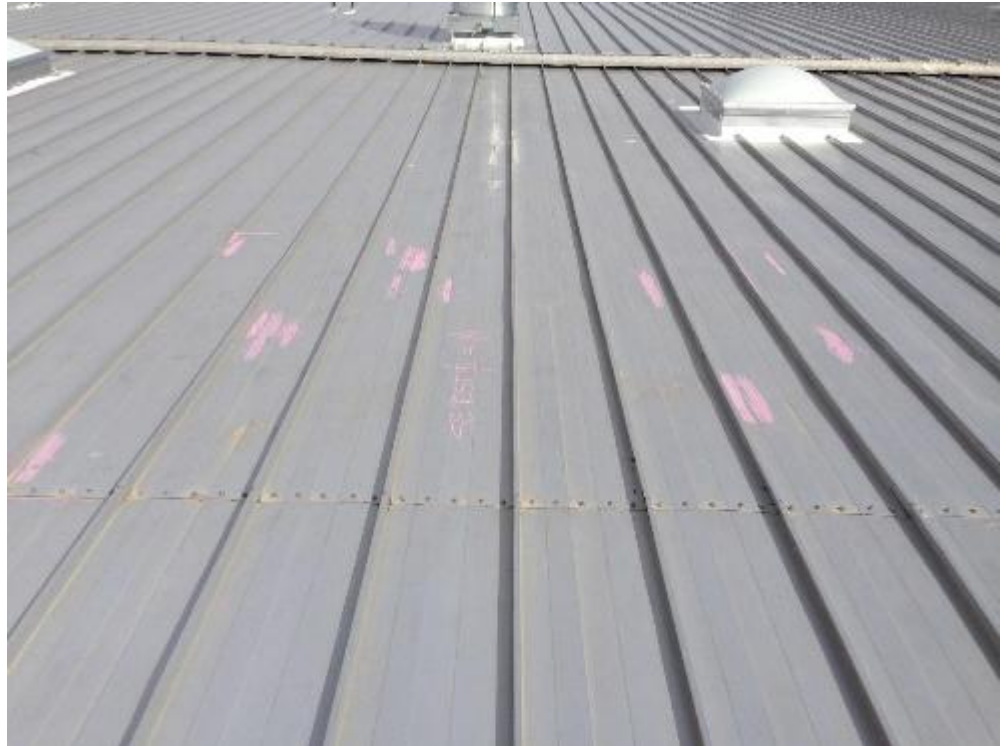
17 SE Test Quare Overvi

Results of the South East test square was 10 hits per square.

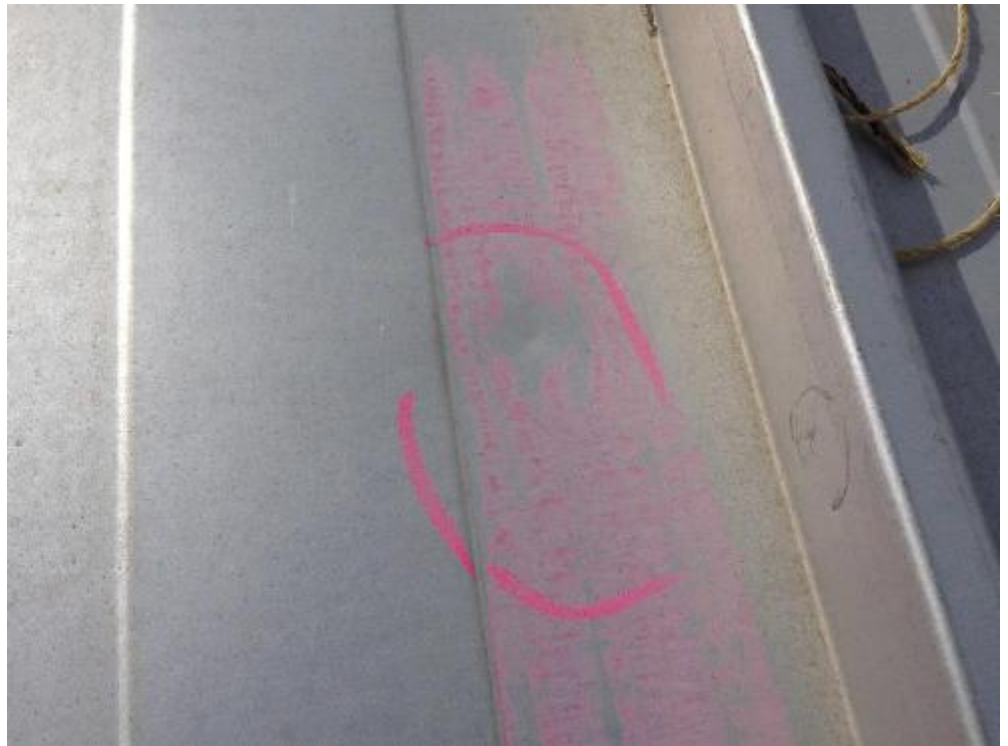
18 SE Test Square Impac

Note the round nature of the dent, this size and depth is consistent with the size of hail and construction of the system.

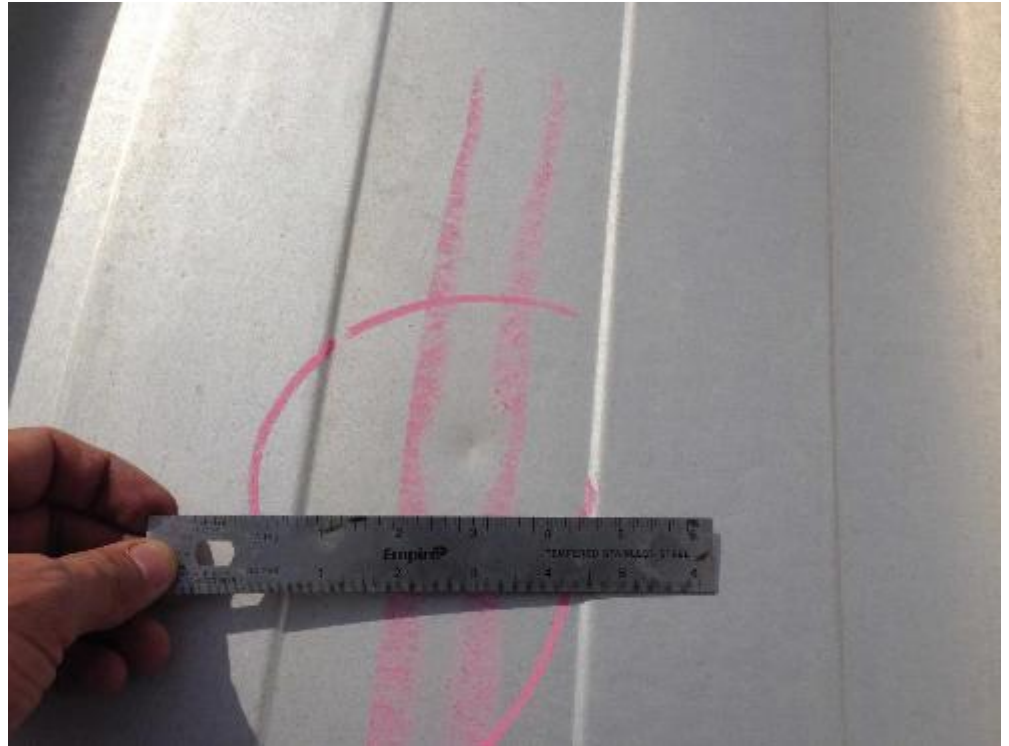
21 SE Test Square Impac
Date Taken: 10/8/2013
Taken By: Derek O'Driscoll

Note the rust and corrosion showing in the hail depression.

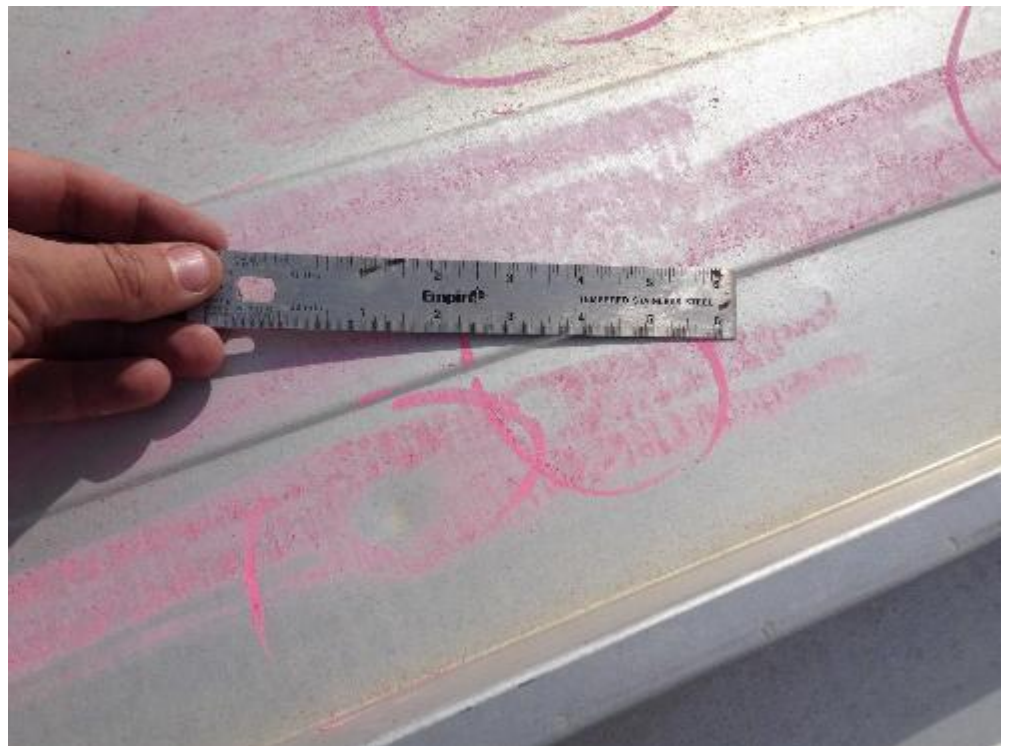
22 SE Test Square Impac
Date Taken: 10/8/2013
Taken By: Derek O'Driscoll

Note the rust and corrosion showing in the hail depression.

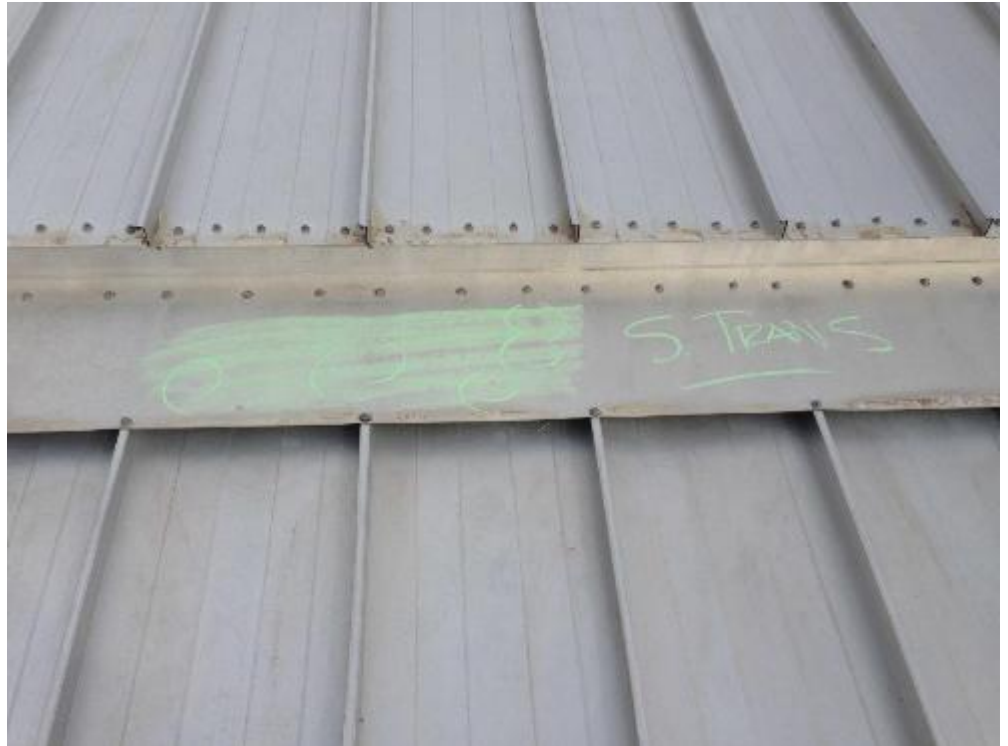
27 South Transition Imp
Date Taken: 10/8/2013
Taken By: Derek O'Driscoll

This is the transition in the elevations on the south slope. Note the dents in the metal consistent with observed hail damage.

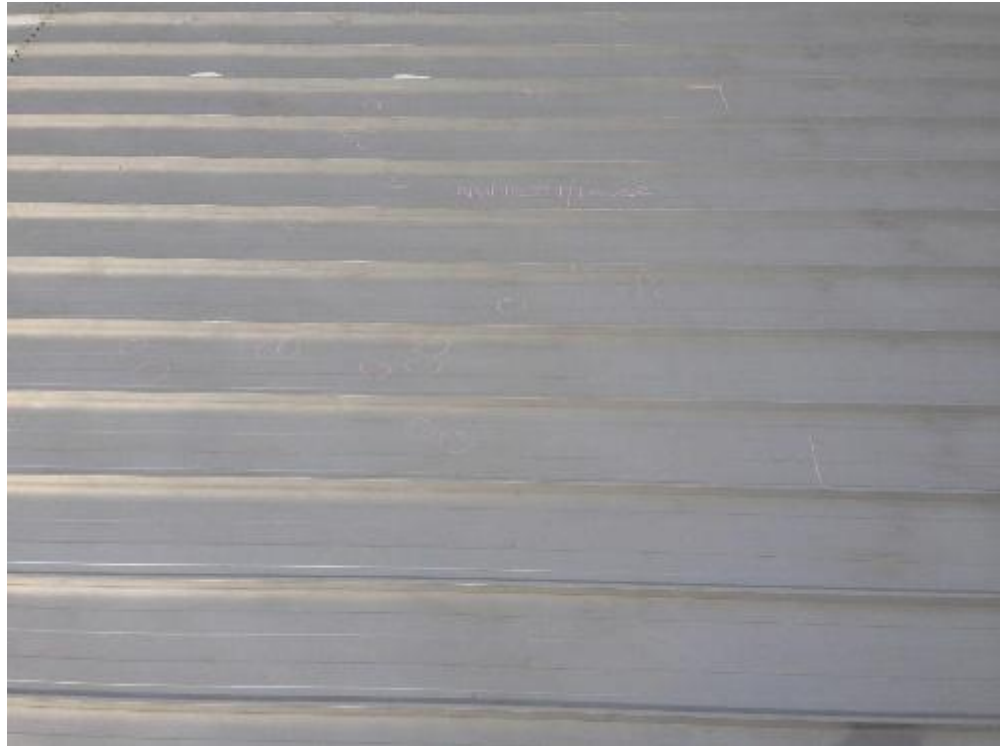
35 NW Test Square Overv

North West Test Square identifier and results.

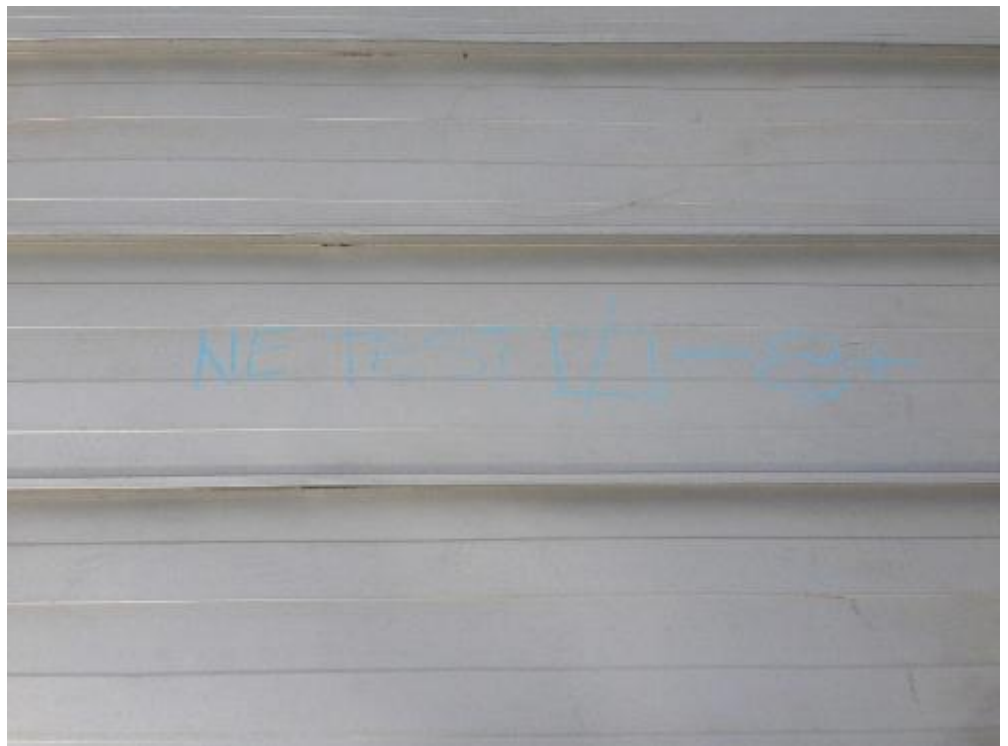
44 NE Test Square Ident

The North East test square identifier.

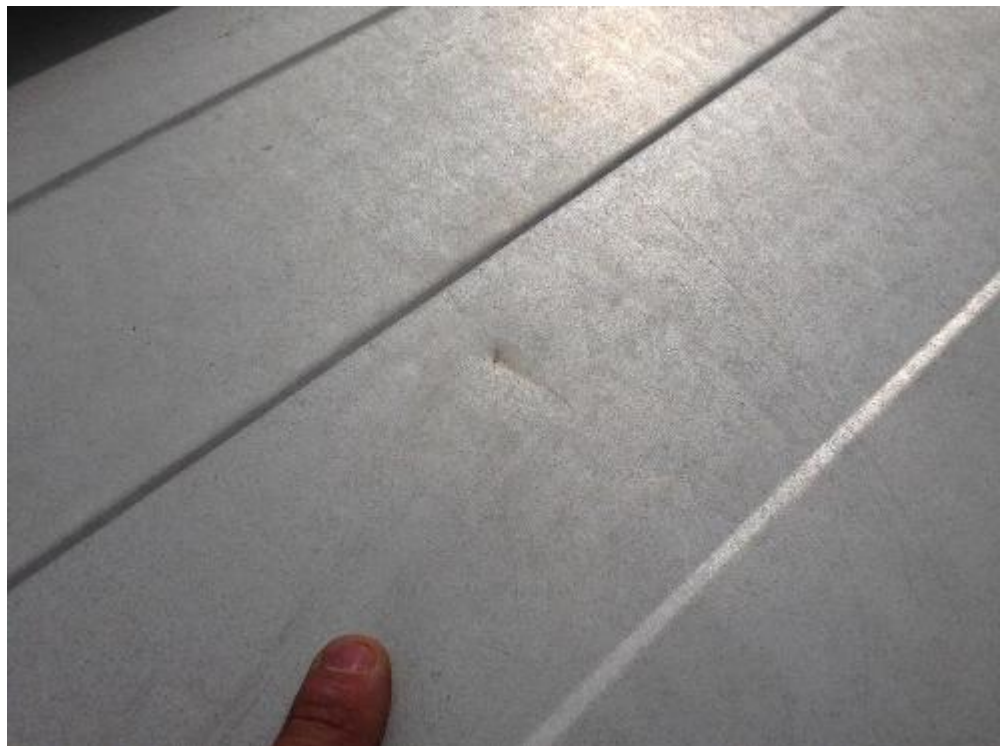
48 NE Test Square Mecha
Date Taken: 10/8/2013
Taken By: Derek O'Driscoll

Note the difference in this dent than the dent from hail damage. The is sharp and scratched, indicating it was caused by something other than hail.

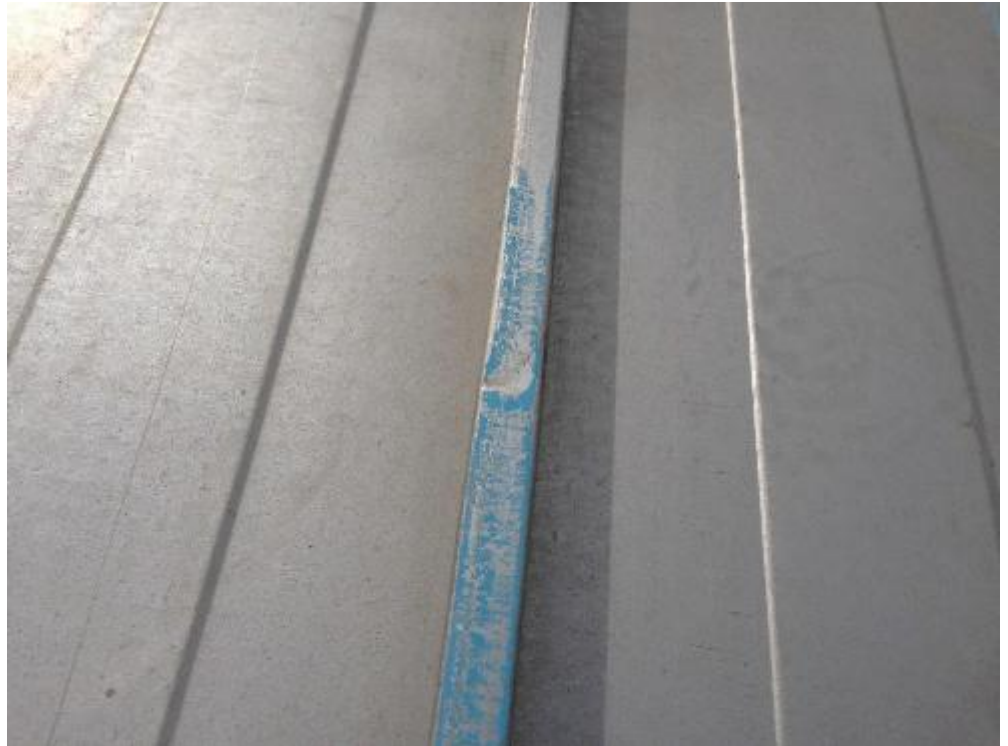
49 NE Test Square Mecha
Date Taken: 10/8/2013
Taken By: Derek O'Driscoll

Note the damage caused to the ridge by hail stone impact.

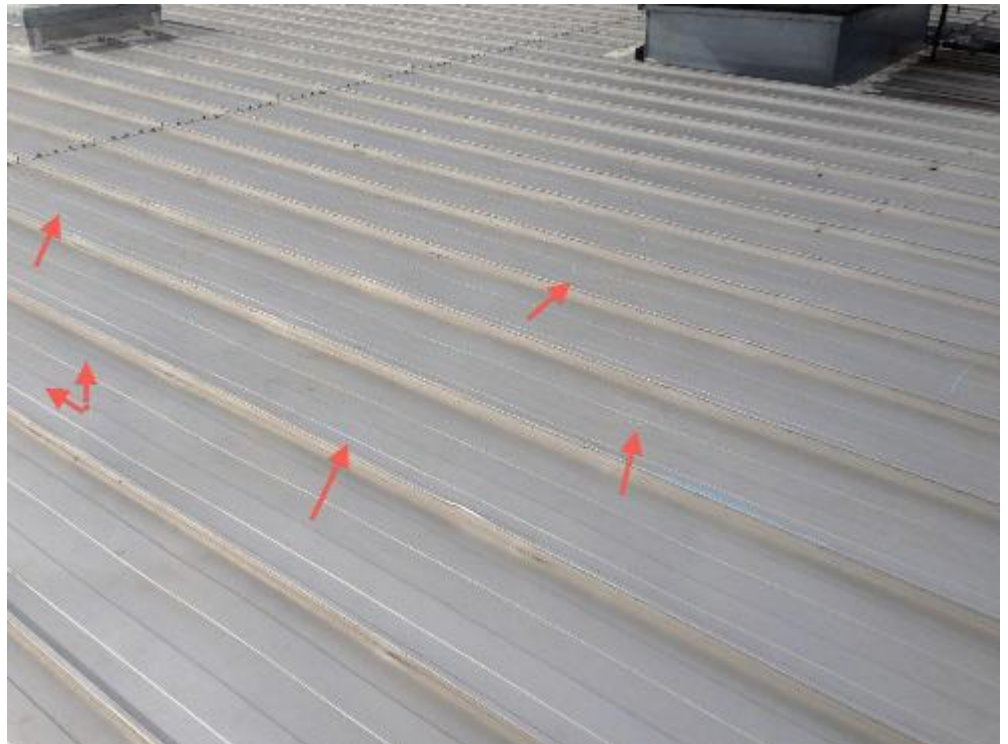
50 NE Test Square Overv
Date Taken: 10/8/2013
Taken By: Derek O'Driscoll

North East test square results.

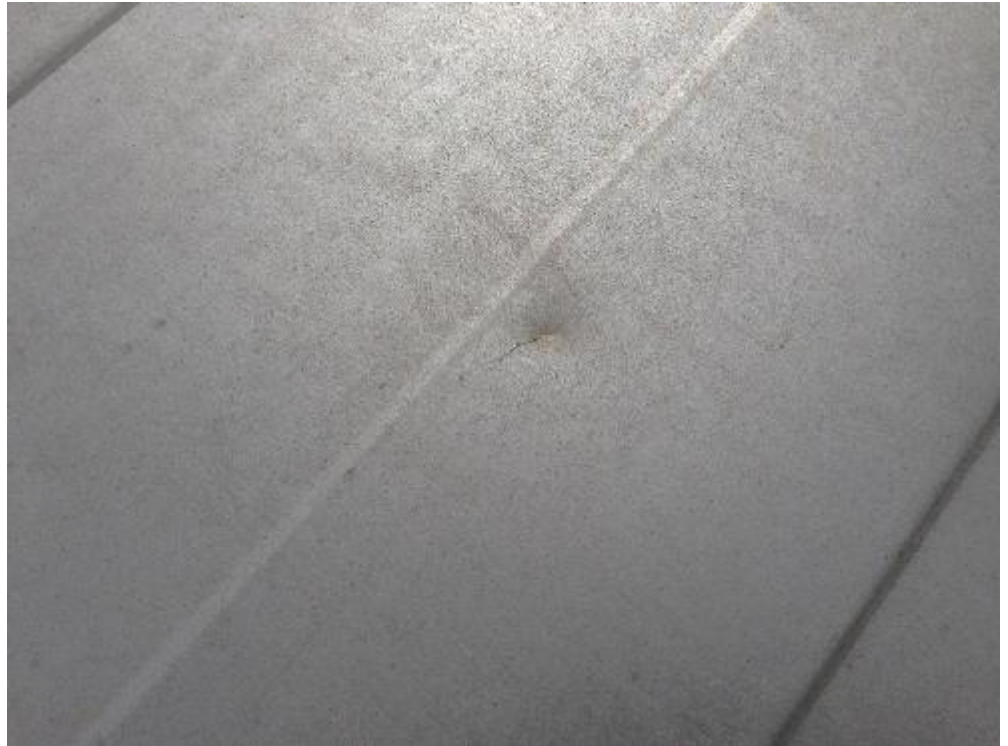
51 Mechanical Damage Sc

Note the amount of rust in this mechanical damage point, it appears to be older than the hail damage due to the amount of corrosion and rust in the depression.

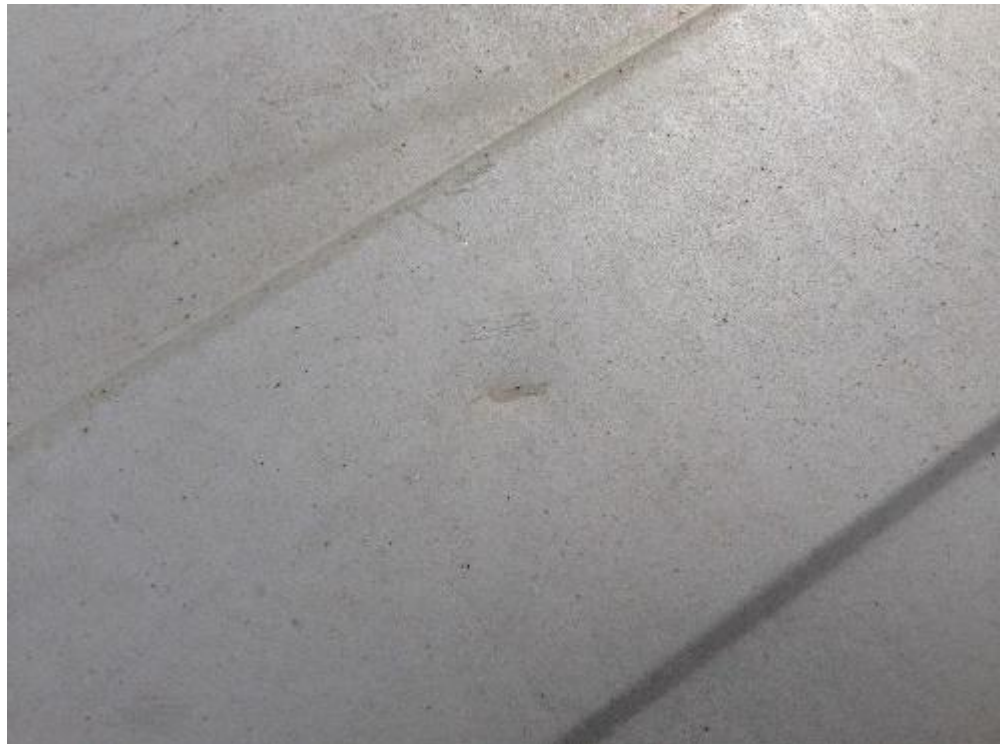
52 Mechanical Damage

Note the amount of rust in this mechanical damage point, it appears to be older than the hail damage due to the amount of corrosion and rust in the depression.

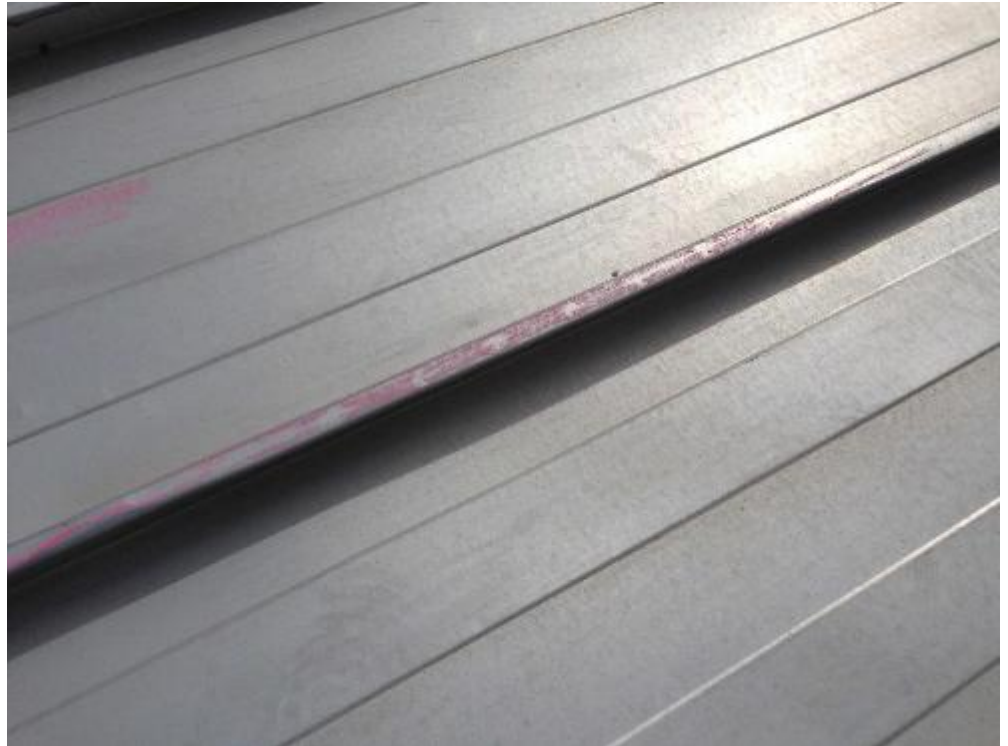
53 Damage caused during
Date Taken: 10/8/2013
Taken By: Derek O'Driscoll

Note the uniformity in these dents,
suggesting it was caused during the
installation of the system.

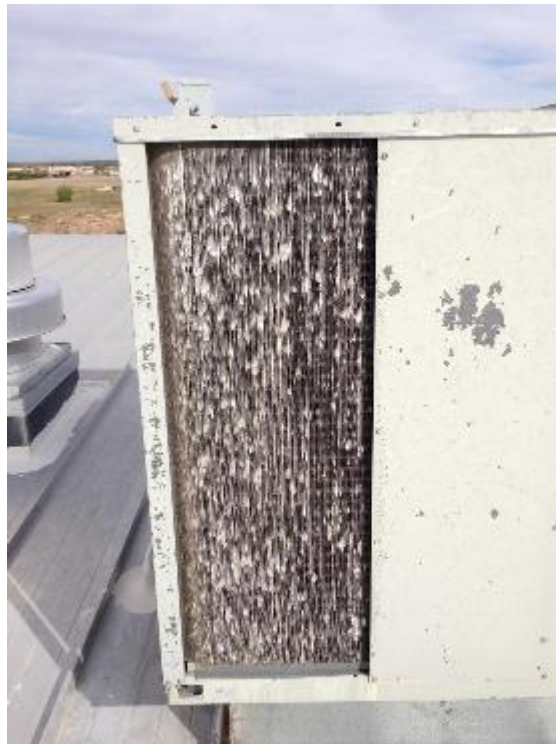
54 IMG_9225
Date Taken: 10/8/2013
Taken By: Derek O'Driscoll

This exposed RTU coil is destroyed,
given the age of the unit it will need
to be replaced as coils are obsolete in
the market place.

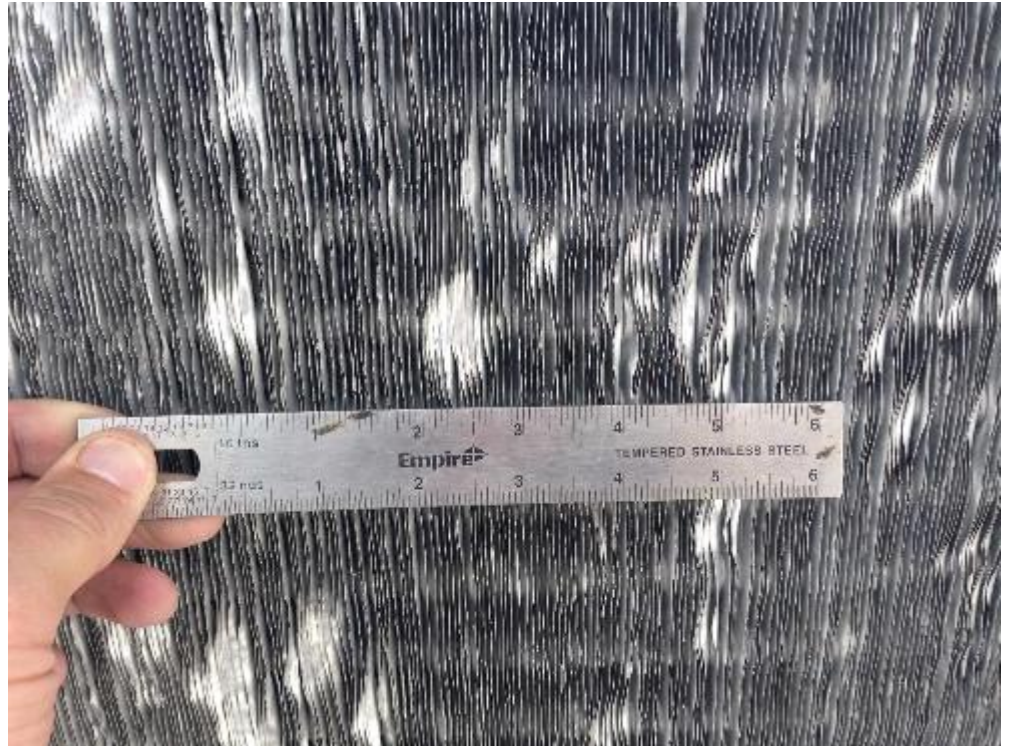
- 55 Close up coil damage
Date Taken: 10/8/2013
Taken By: Derek O'Driscoll
Note the torn and twisted coils.

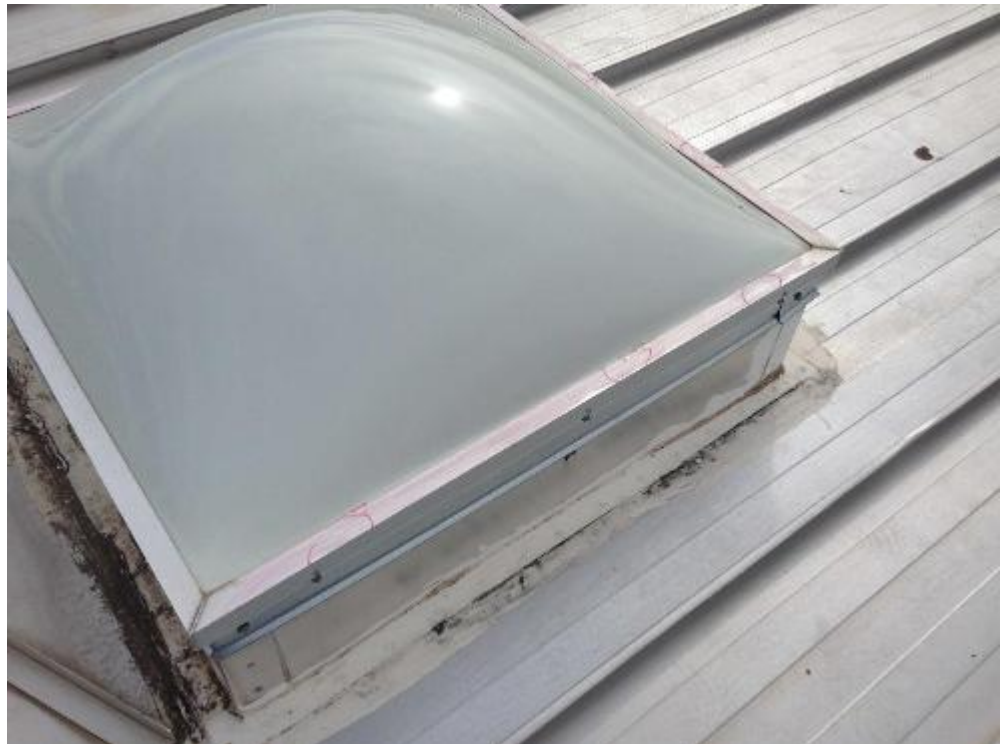
74 Southern Skylight CI
Date Taken: 10/8/2013
Taken By: Derek O'Driscoll

The damage to the skylight cladding is likely a contributing factor to the water intrusion at these points.

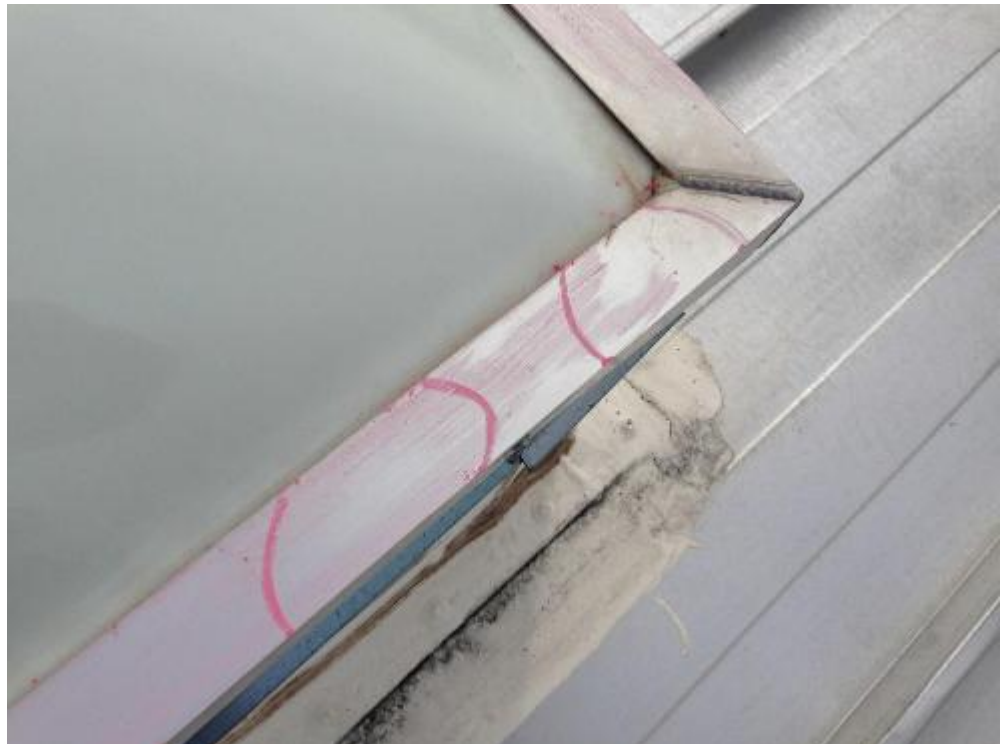
76 Southern Skylight CI
Date Taken: 10/8/2013
Taken By: Derek O'Driscoll

Size and shape consistent with previously observed damage and report hail characteristics.
