Commercial Property Report

Production Facility

18501 [REDACTED] Drive
Parker, CO 80134

Introduction

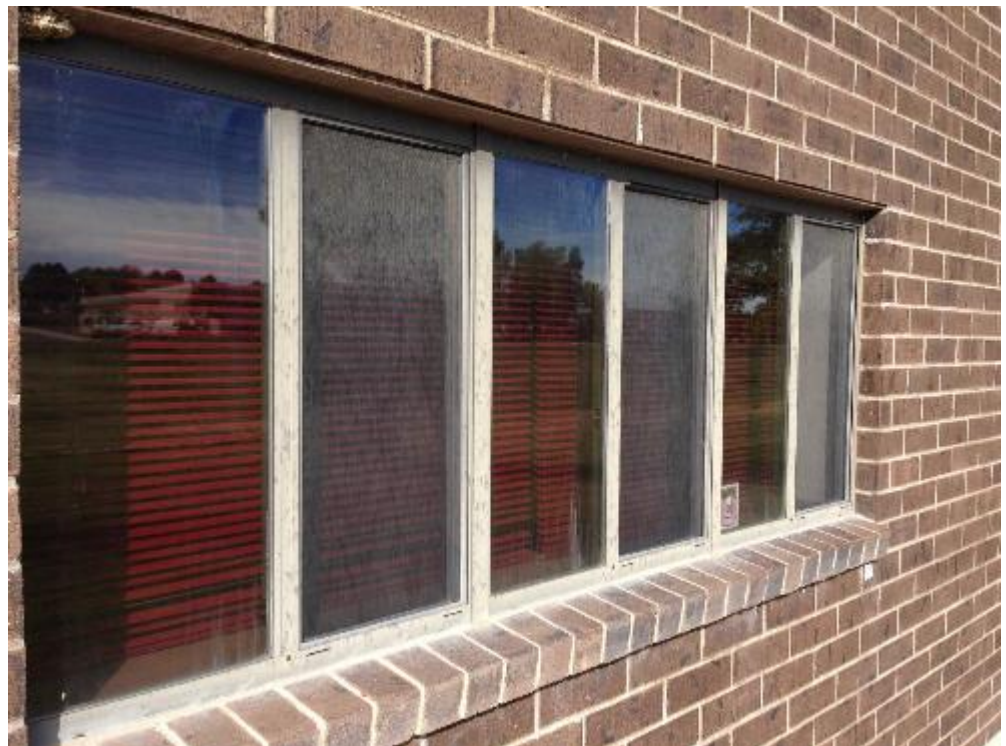
- 2 IMG_9177
Date Taken: 10/8/2013
Taken By: Derek O'Driscoll

Note the "oxidized spatter" marks around the windows. This is a effect of hail cleaning the oxidation off the material upon impact.

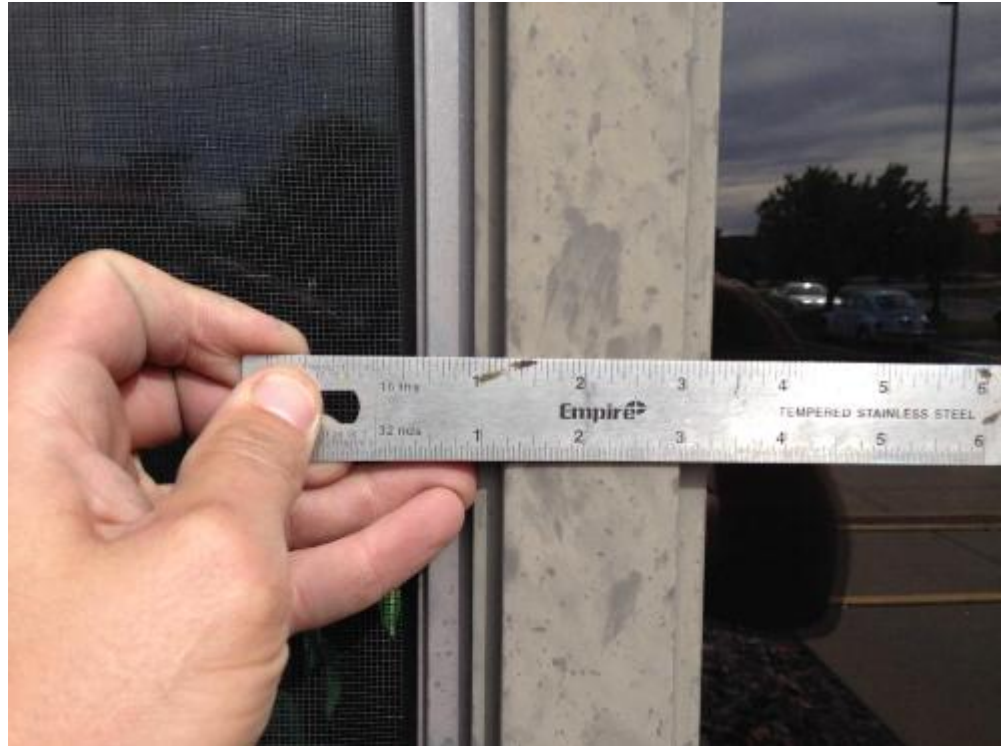
3 Oxidation Impacts 2

Oxidation Marks are consistent with the reported hail size at the property on the date of loss.

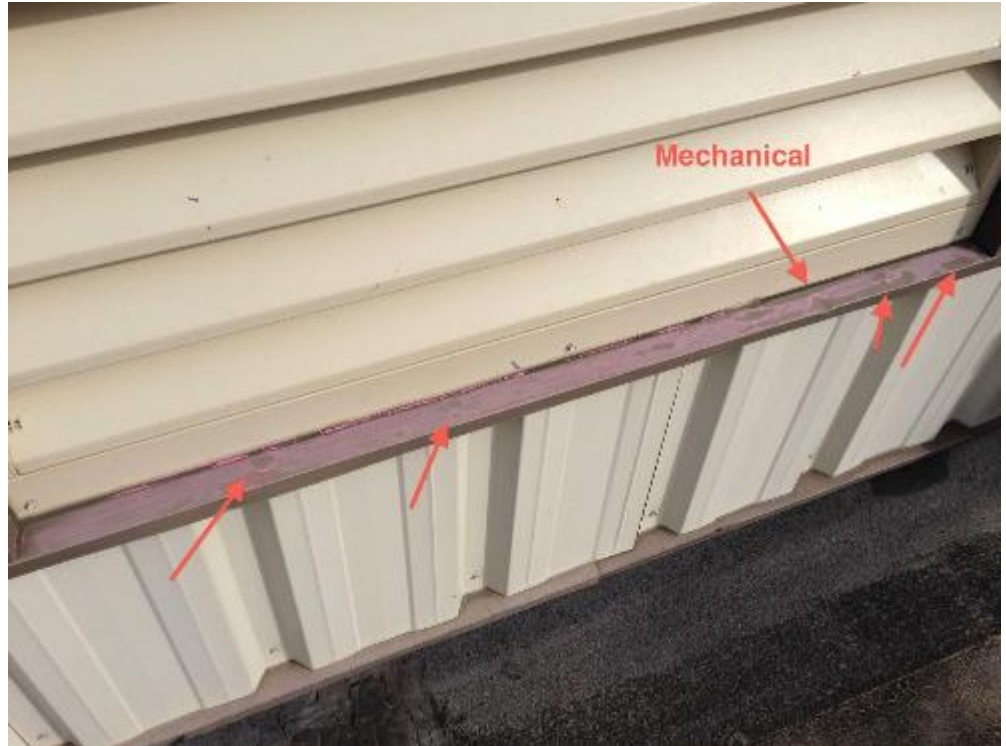
The side wall exhaust grates also show dents as a result of hail stoned impacts. Note the difference in the "mechanical" dent, the size and crease in the dent indicate this was done by a sharp metal object.

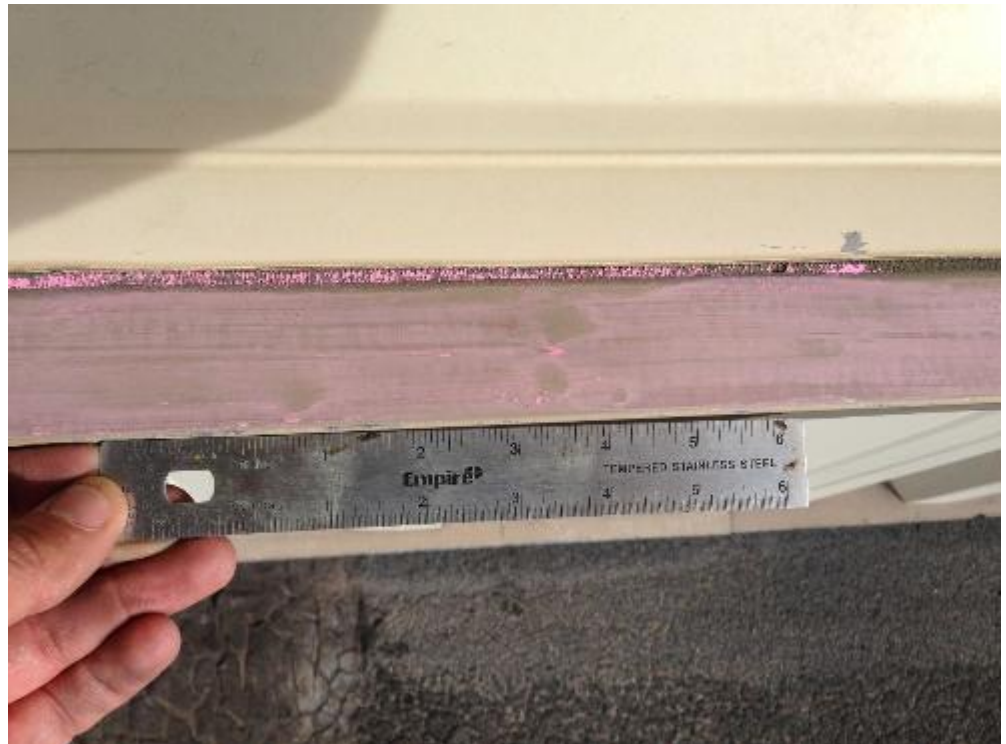
10 IMG_9188

The size of the dents are consistent with the reported hail size at the property.

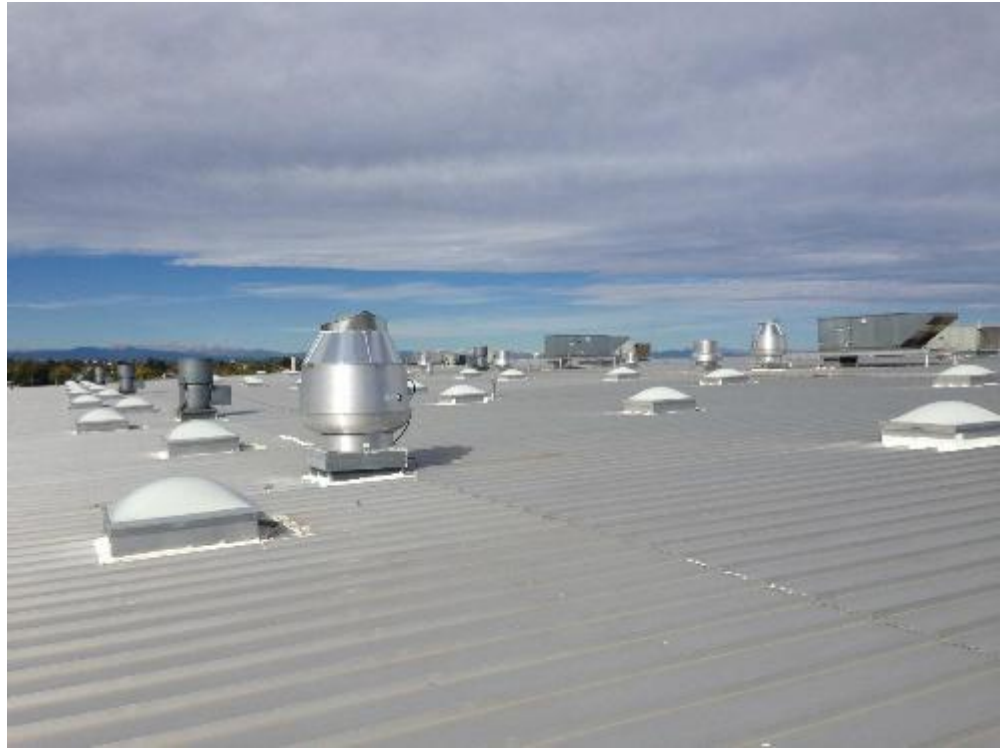
This is an overview from the SE corner looking WNW.

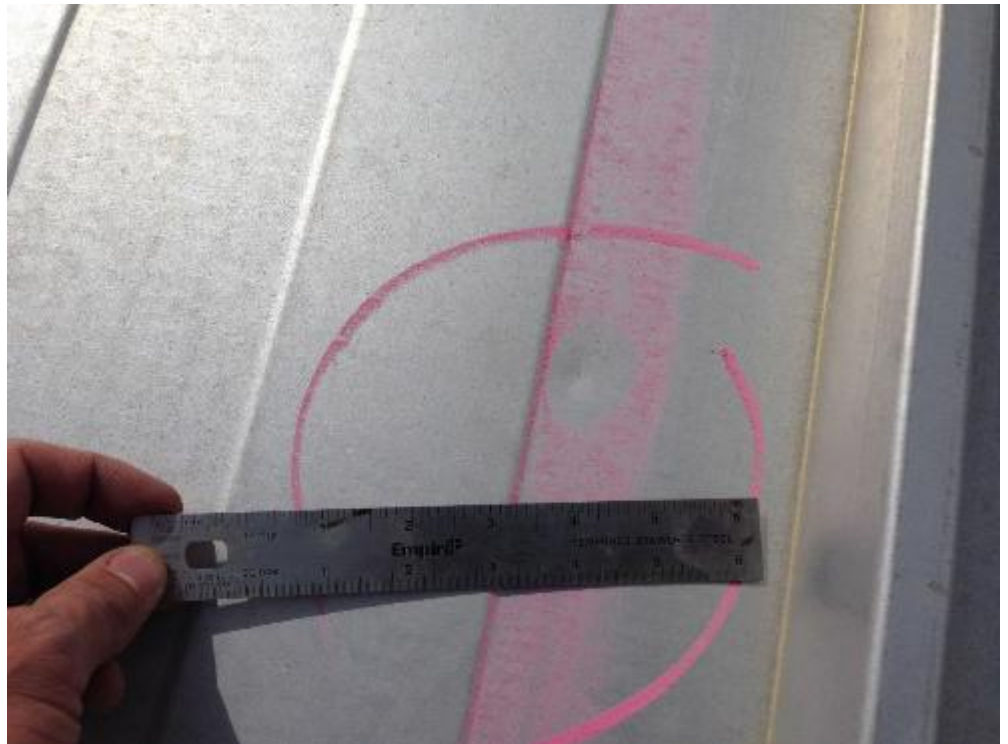
21 SE Test Square Impac
Date Taken: 10/8/2013
Taken By: Derek O'Driscoll

Note the rust and corrosion showing in the hail depression.

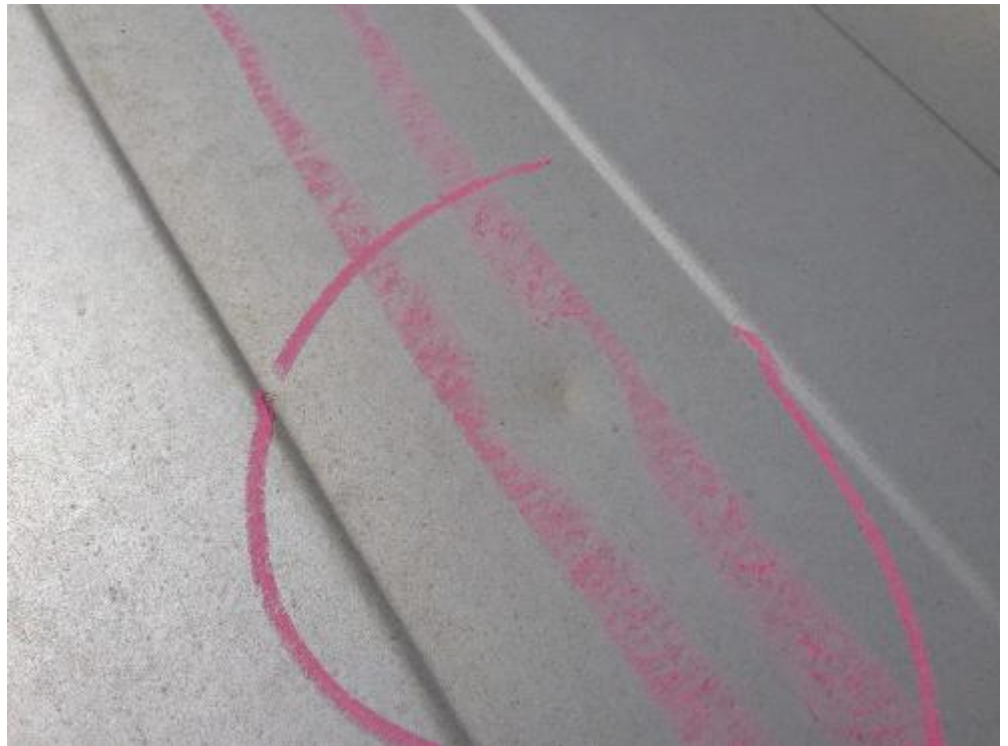
27 South Transition Imp
Date Taken: 10/8/2013
Taken By: Derek O'Driscoll

This is the transition in the elevations on the south slope. Note the dents in the metal consistent with observed hail damage.

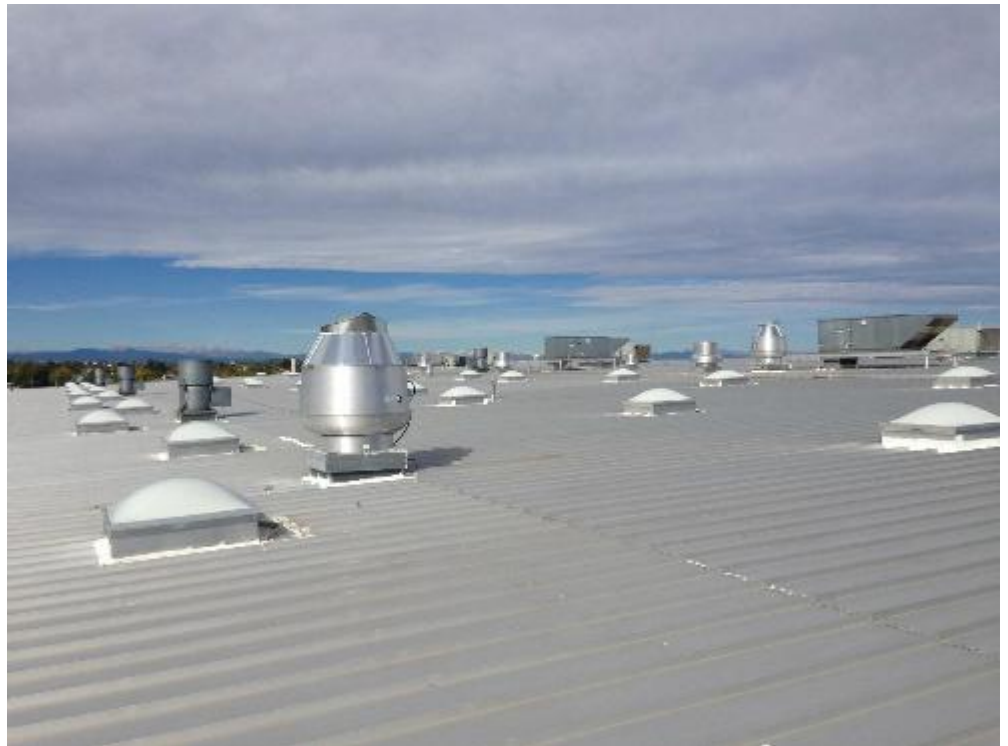
34 NW Overview Photo
Date Taken: 10/8/2013
Taken By: Derek O'Driscoll
This is the overview from the
Northwest Corner looking South East.

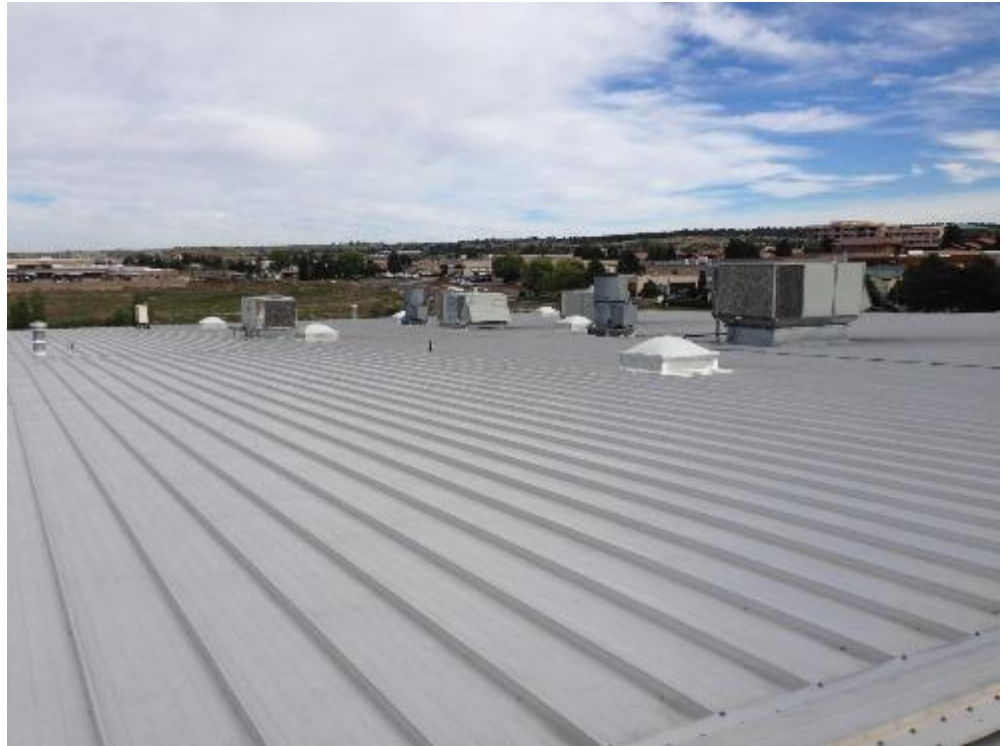
This overview is the middle of the roof facing North.

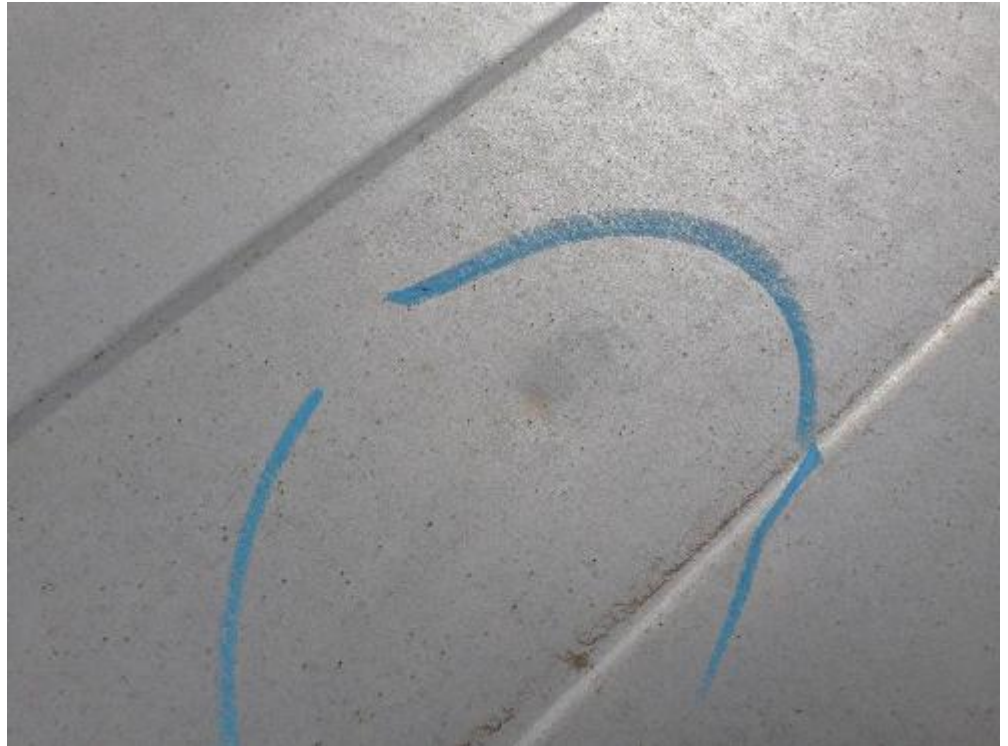
48 NE Test Square Mecha
Date Taken: 10/8/2013
Taken By: Derek O'Driscoll

Note the difference in this dent than the dent from hail damage. The is sharp and scratched, indicating it was caused by something other than hail.

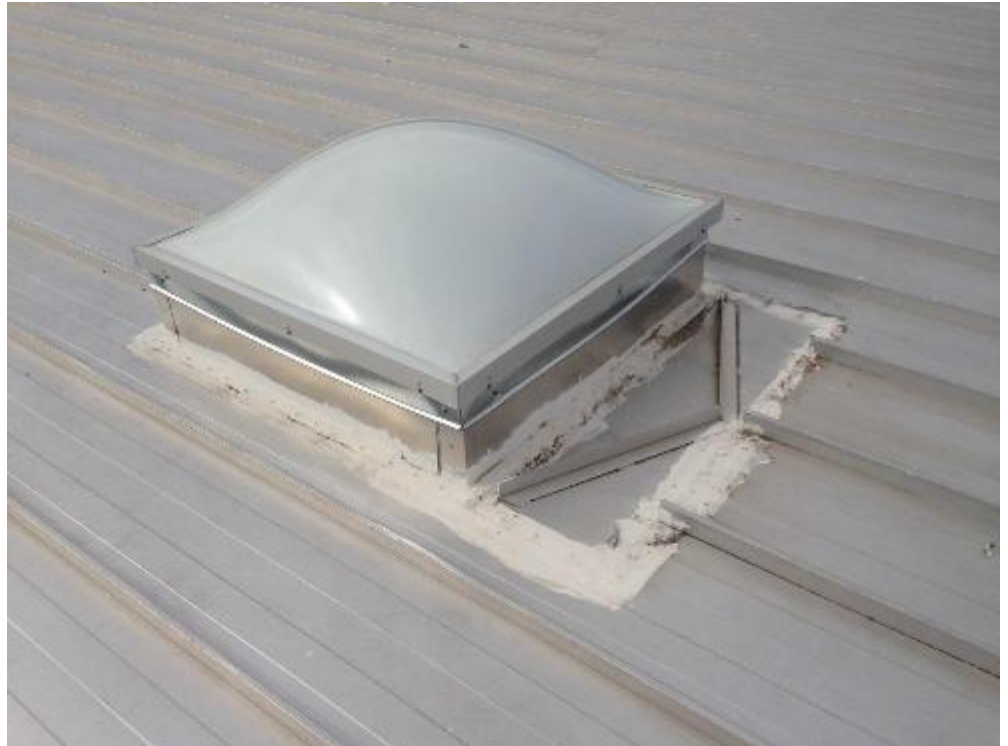
74 Southern Skylight CI
Date Taken: 10/8/2013
Taken By: Derek O'Driscoll

The damage to the skylight cladding is likely a contributing factor to the water intrusion at these points.

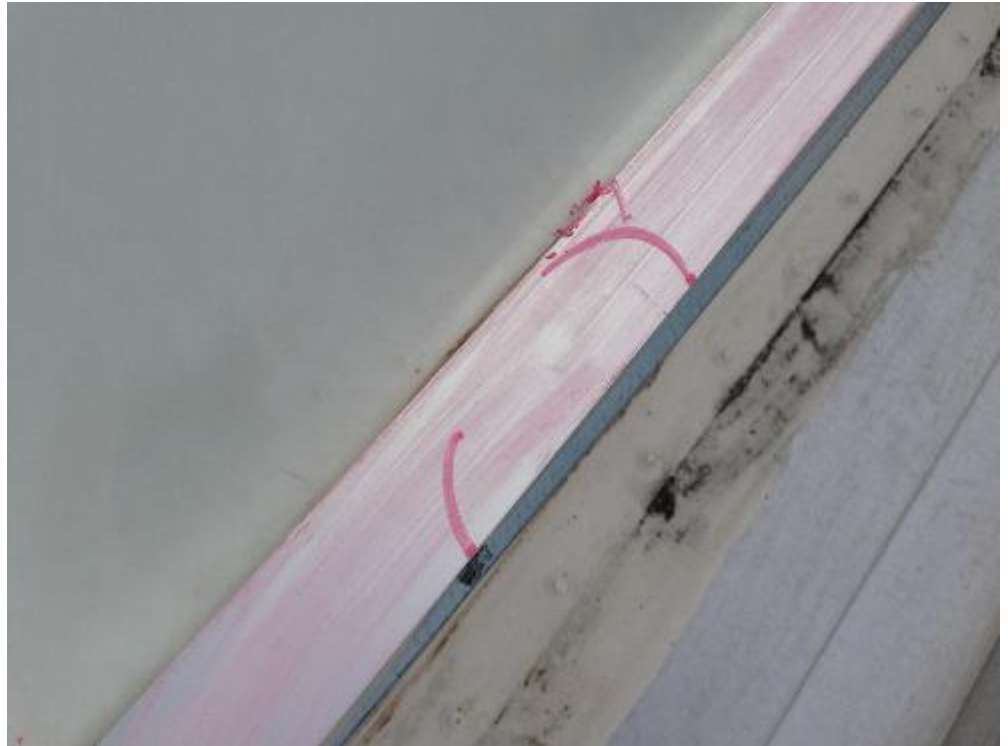
76 Southern Skylight CI
Date Taken: 10/8/2013
Taken By: Derek O'Driscoll

Size and shape consistent with previously observed damage and report hail characteristics.

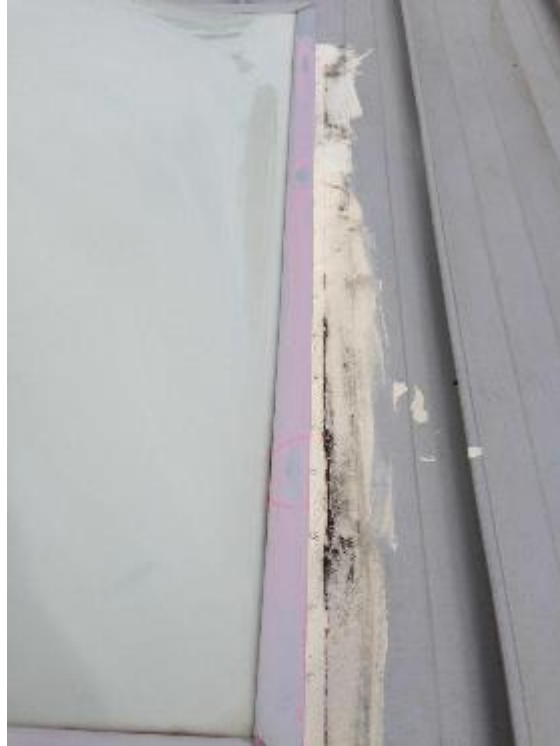
78 Southern Skylight CI
Date Taken: 10/8/2013
Taken By: Derek O'Driscoll
